The Determination of Accessible Taxi Requirements

PPAD 9/72/87 (UG539)

Mobility and Inclusion Unit,
Department for Transport

June 2004

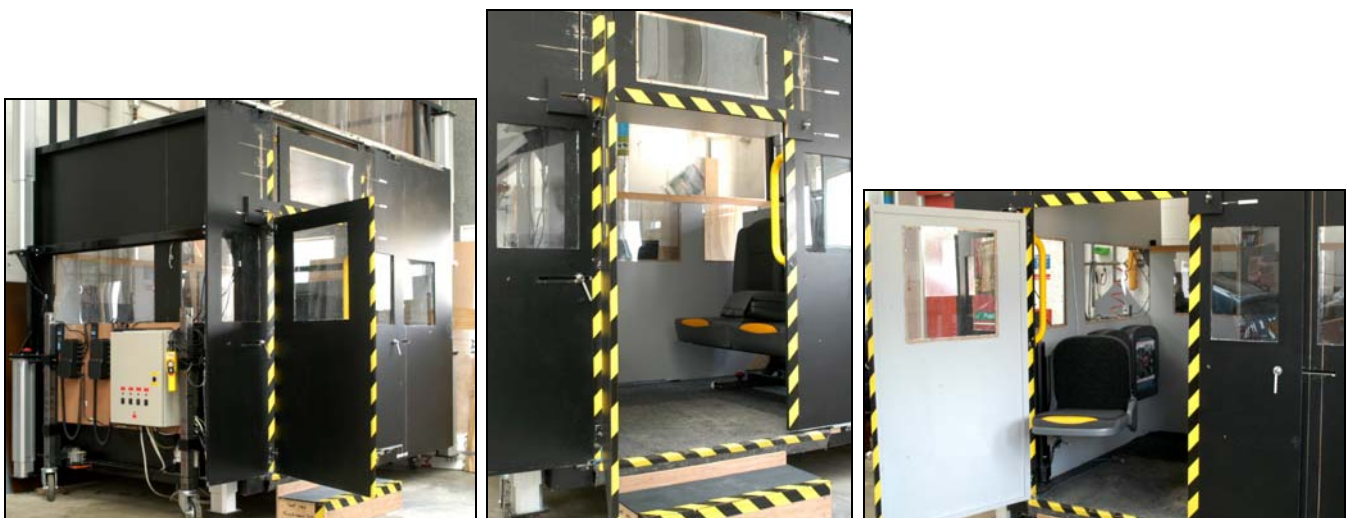
A fully adjustable assessment rig was developed specifically for the trial (See Figure1). The adjustments for floor and ceiling height were electrically controlled, while the door opening and seat position were adjusted manually. An electrically controlled swivel seat was also installed and tested by those participants who felt it might be helpful to them. The participants were also able to assess the suitability of a manual swivel seat fitted to a standard saloon car.

The rig was not intended to represent any particular manufacturer's vehicle but the general layout was consistent with a wheelchair accessible taxi with side door access.

Figure 1: Taxi rig

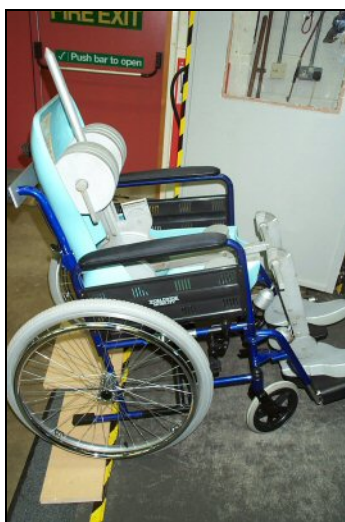
A series of test measurements were made using a popular, lightweight wheelchair and the test rig. A range of weights were added to the wheelchair to represent the weight of an adult occupant using an H-Point manikin.

An H-Point manikin is a gauging tool used in the design, measurement and adjustment of vehicle seating. It comprises a hinged shell intended to represent the back and thighs of a seat occupant. Articulated legs and weights can be added to the shell to provide a range of realistic weights. The weight distribution approximates that of an adult occupant.

Figure 2: Wheelchair and manikin used in test measurements

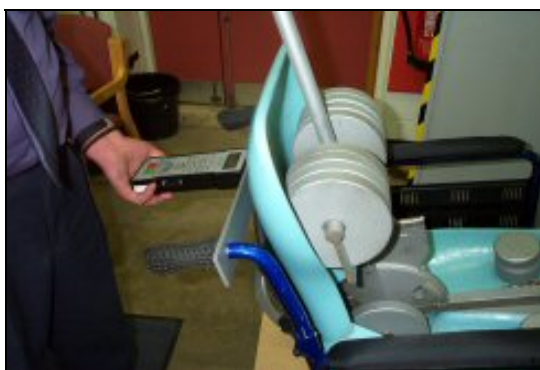
The measurements were obtained by way of a steady thrust applied through a force dynamometer applied to a metal plate fixed between the wheelchair handles. The force was thus applied at the same height as a two handled push although achieving a uniform push through single point proved a challenge (see Figure 3). Attempts to take measurements with the steepest ramp angle and heaviest load were abandoned because it proved impossible to achieve a consistent and controlled push effort. Each measurement was repeated ten times and a mean value calculated to reduce error caused by variation in push efforts.

Figure 3: Measurement of push effort

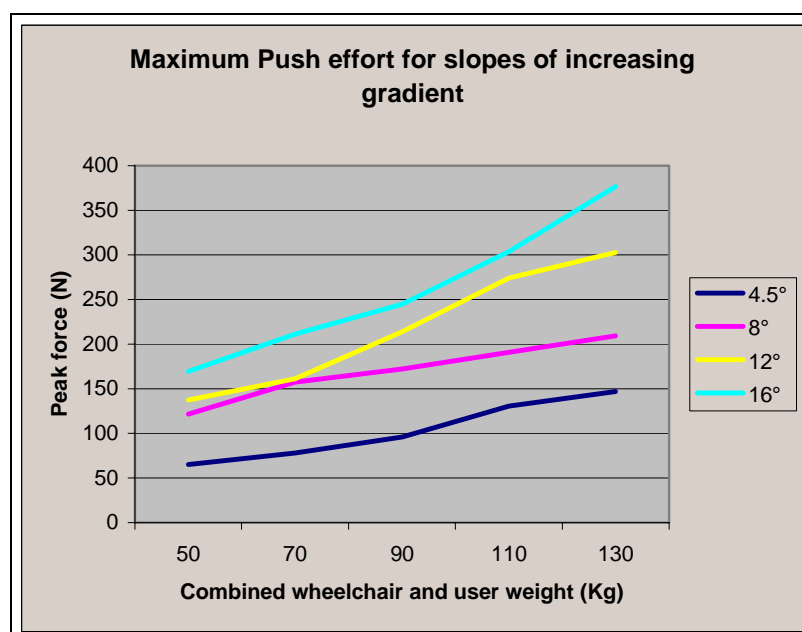
However, there is a clear increase in effort associated with both increasing weight and slope. Figure 4 shows the data plotted and the general trend along with variation in progression is evident.

Figure 4: Mean push forces for a range of combined wheelchair weights and ramp angles

The variation in the trend data indicates uncontrolled variation in the test procedure – variation that could be reduced with a more sophisticated methodology. However, the underlying trend is clear – increasing slope and weight requires a substantially stronger push effort from the assistant.

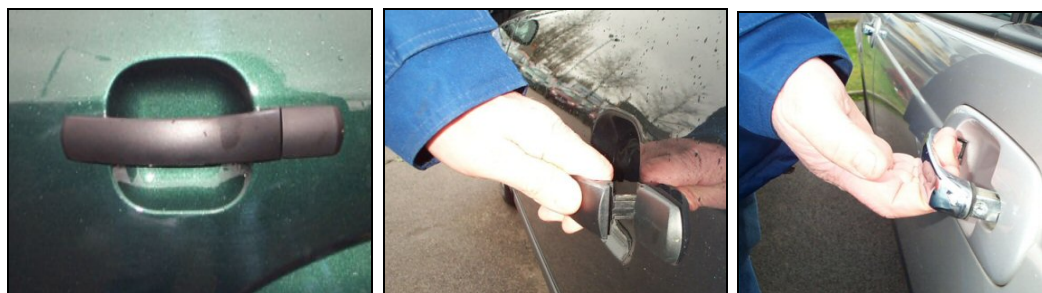
All three types of handle can be operated using the hook grip. However only handle A can be used with both types of grip.

Figure 5: Handle A

Type A handles are also better at accommodating the use of assistive equipment. Figure 8 depicts a device used to assist in

opening a car door handle of type B; while effective the device is purpose designed. The shape of handle A facilitates use of more general devices i.e. walking stick or prosthetic hand or hook.

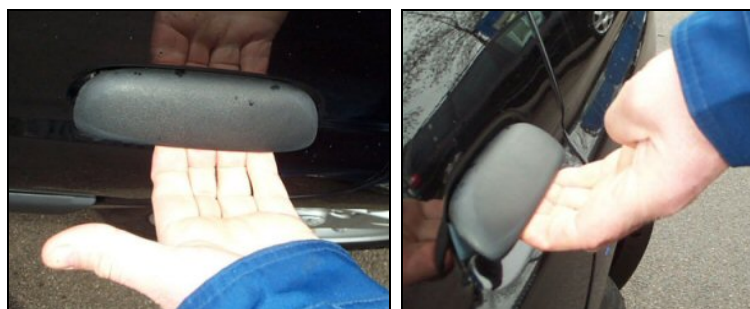
**Figure 6: Handle B**

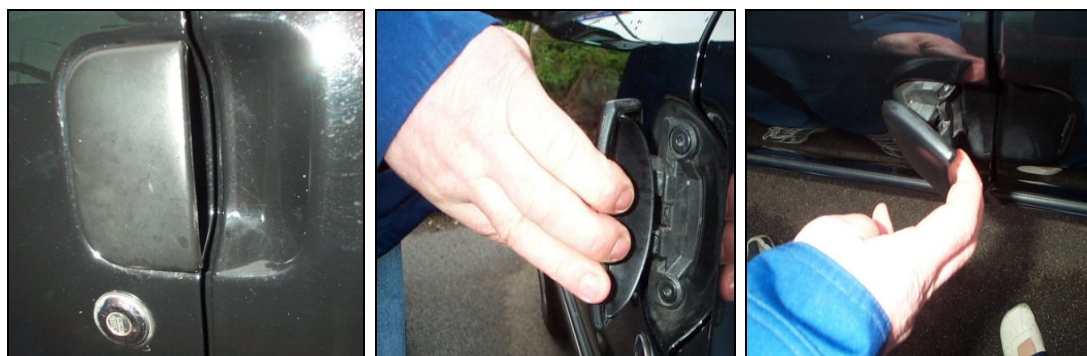
**Figure 7: Handle C**

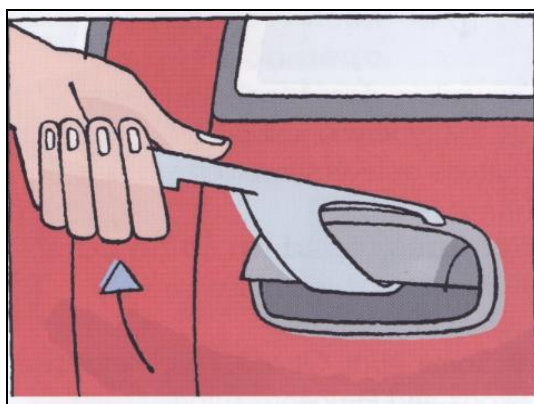
Figure 8: Door opener

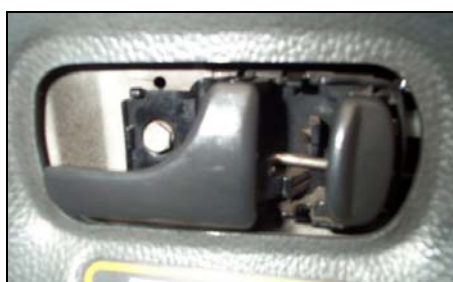
The latch handle depicted in Figure 9 is a design employed in LTI's TX vehicles but handles of this design are commonly used in a wide range of contemporary vehicles. The handle is located flush against the side of the door and must be grasped using a pinch grip or a one or two finger hook grip. To pull the lever of the catch outwards to unlock / unlatch the door, the forearm is drawn inwards towards the body's centre line. This action enables a strong leverage from the arm and does not require excessive wrist extension or excess forearm rotation.

To gain an indication of the force required to pull the lever measurements were taken from 6 different TX vehicles. The forces were low, with a mean value of 4.3N. There is limited published guidance on maximum acceptable lever forces; the Rail Vehicle Accessibility Regulations guidance suggests a maximum value of 15N for operating train door handles and BS 4467; 1991 suggests

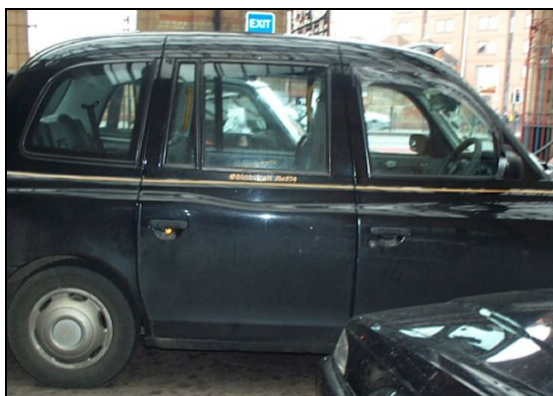
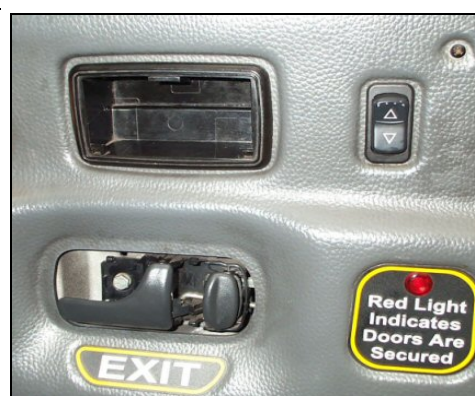
Passengers with restricted vision reported that both exterior and interior handles were not always easy to find. Figures 11 and 12 demonstrate that both types of handles would benefit from being made more conspicuous. Better colour contrast of the handles with their background would make them more conspicuous and therefore easier for the partially sighted to locate. In addition, tactile feedback may also aid a range of users in locating the interior handle. A tactile border around the interior latch is recommended, this will assist in its differentiation from other devices commonly found on the door panel such as cigarette ash trays and window winders / switches. 'Courtesy' lighting could also be used to hi-light the location of the door handles and to differentiate them from adjacent objects. The taxi in figure 11 has a small light below the handle which draws attention its location.

A contrast colour outlining the opening edge of the door may also be beneficial in terms of indicating the direction of door opening.

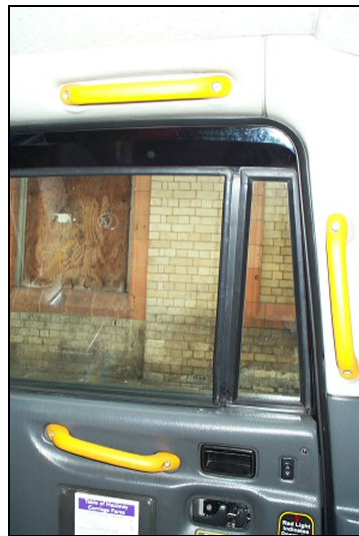
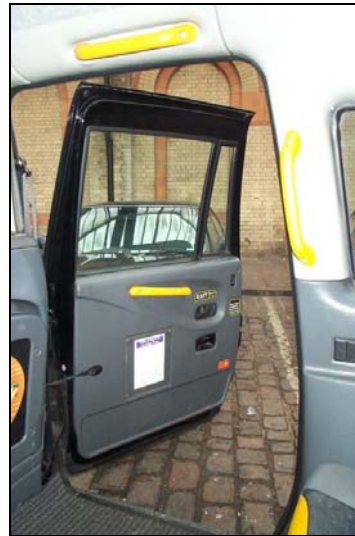
On boarding a vehicle and manoeuvring within it disabled passengers require additional support. Handrails should be provided on both sides to enable an ambulant passenger to use their strongest arm or to allow for them to carry a walking aid or luggage in their strongest arm. Wheelchair users may find handholds helpful in manoeuvring through taxi doorways, manoeuvring within the passenger compartment and as a form of additional postural support while travelling.

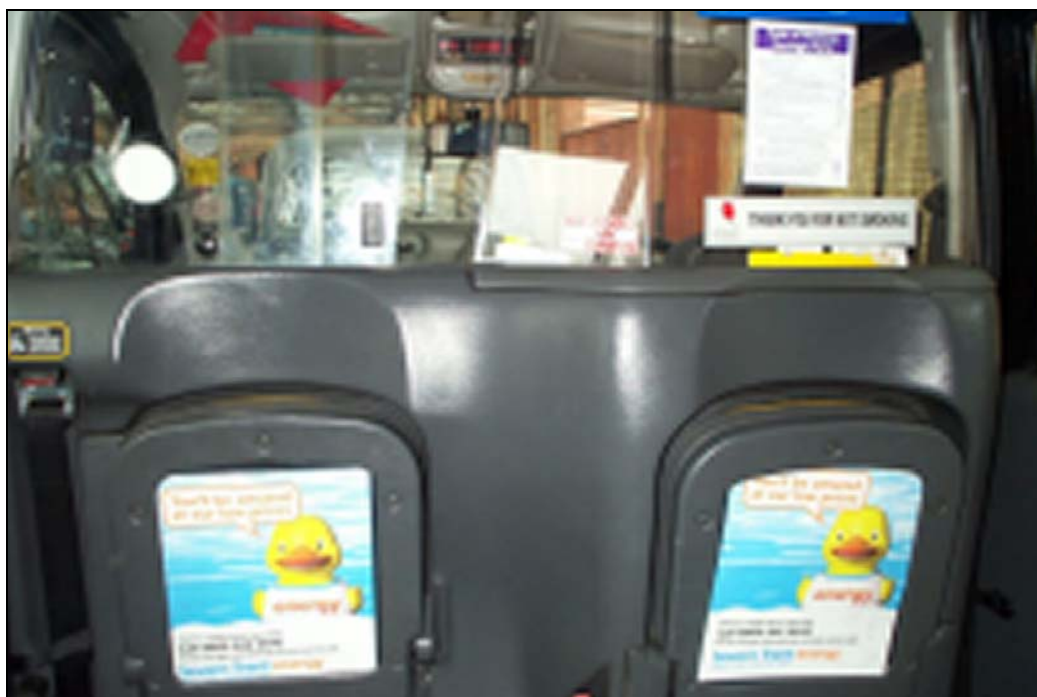
Figure 15: Visual clutter in a taxi

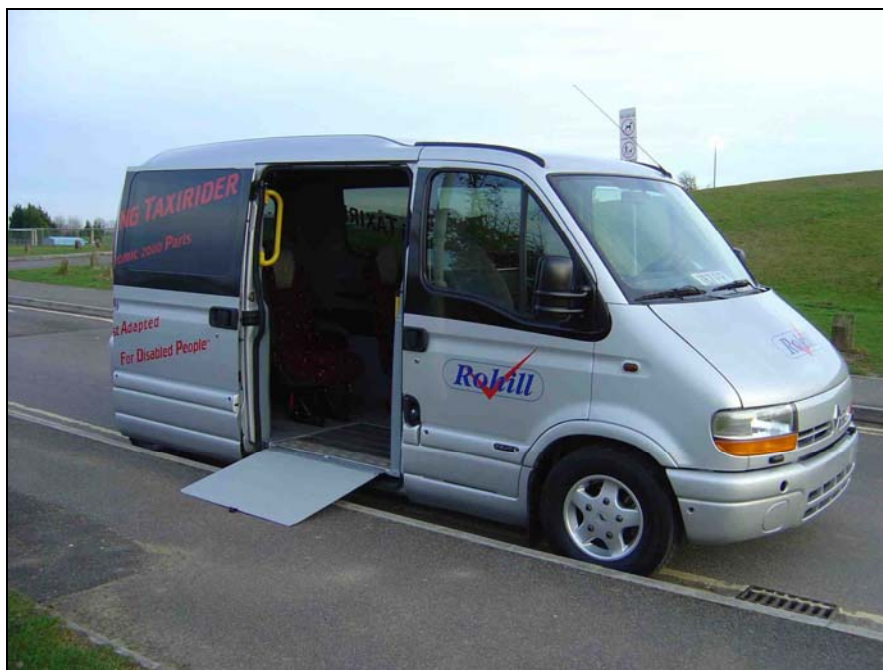
- Kneeling mechanism to give very low floor height
- Sliding door
- High door and roof
- Flexible seating arrangement

Participants were invited to inspect and try getting in and out this vehicle, and report on how easy it was to use. They were also asked if they preferred it over the more familiar purpose built taxis.

Figure 16: Rohill TaxiRider
